# WROUGHT IRON *for* UNDERGROUND SERVICES

A TECHNICAL BULLETIN PREPARED BY THE ENGINEERING SERVICE DEPARTMENT

**A. M. BYERS COMPANY • PITTSBURGH, PA.**

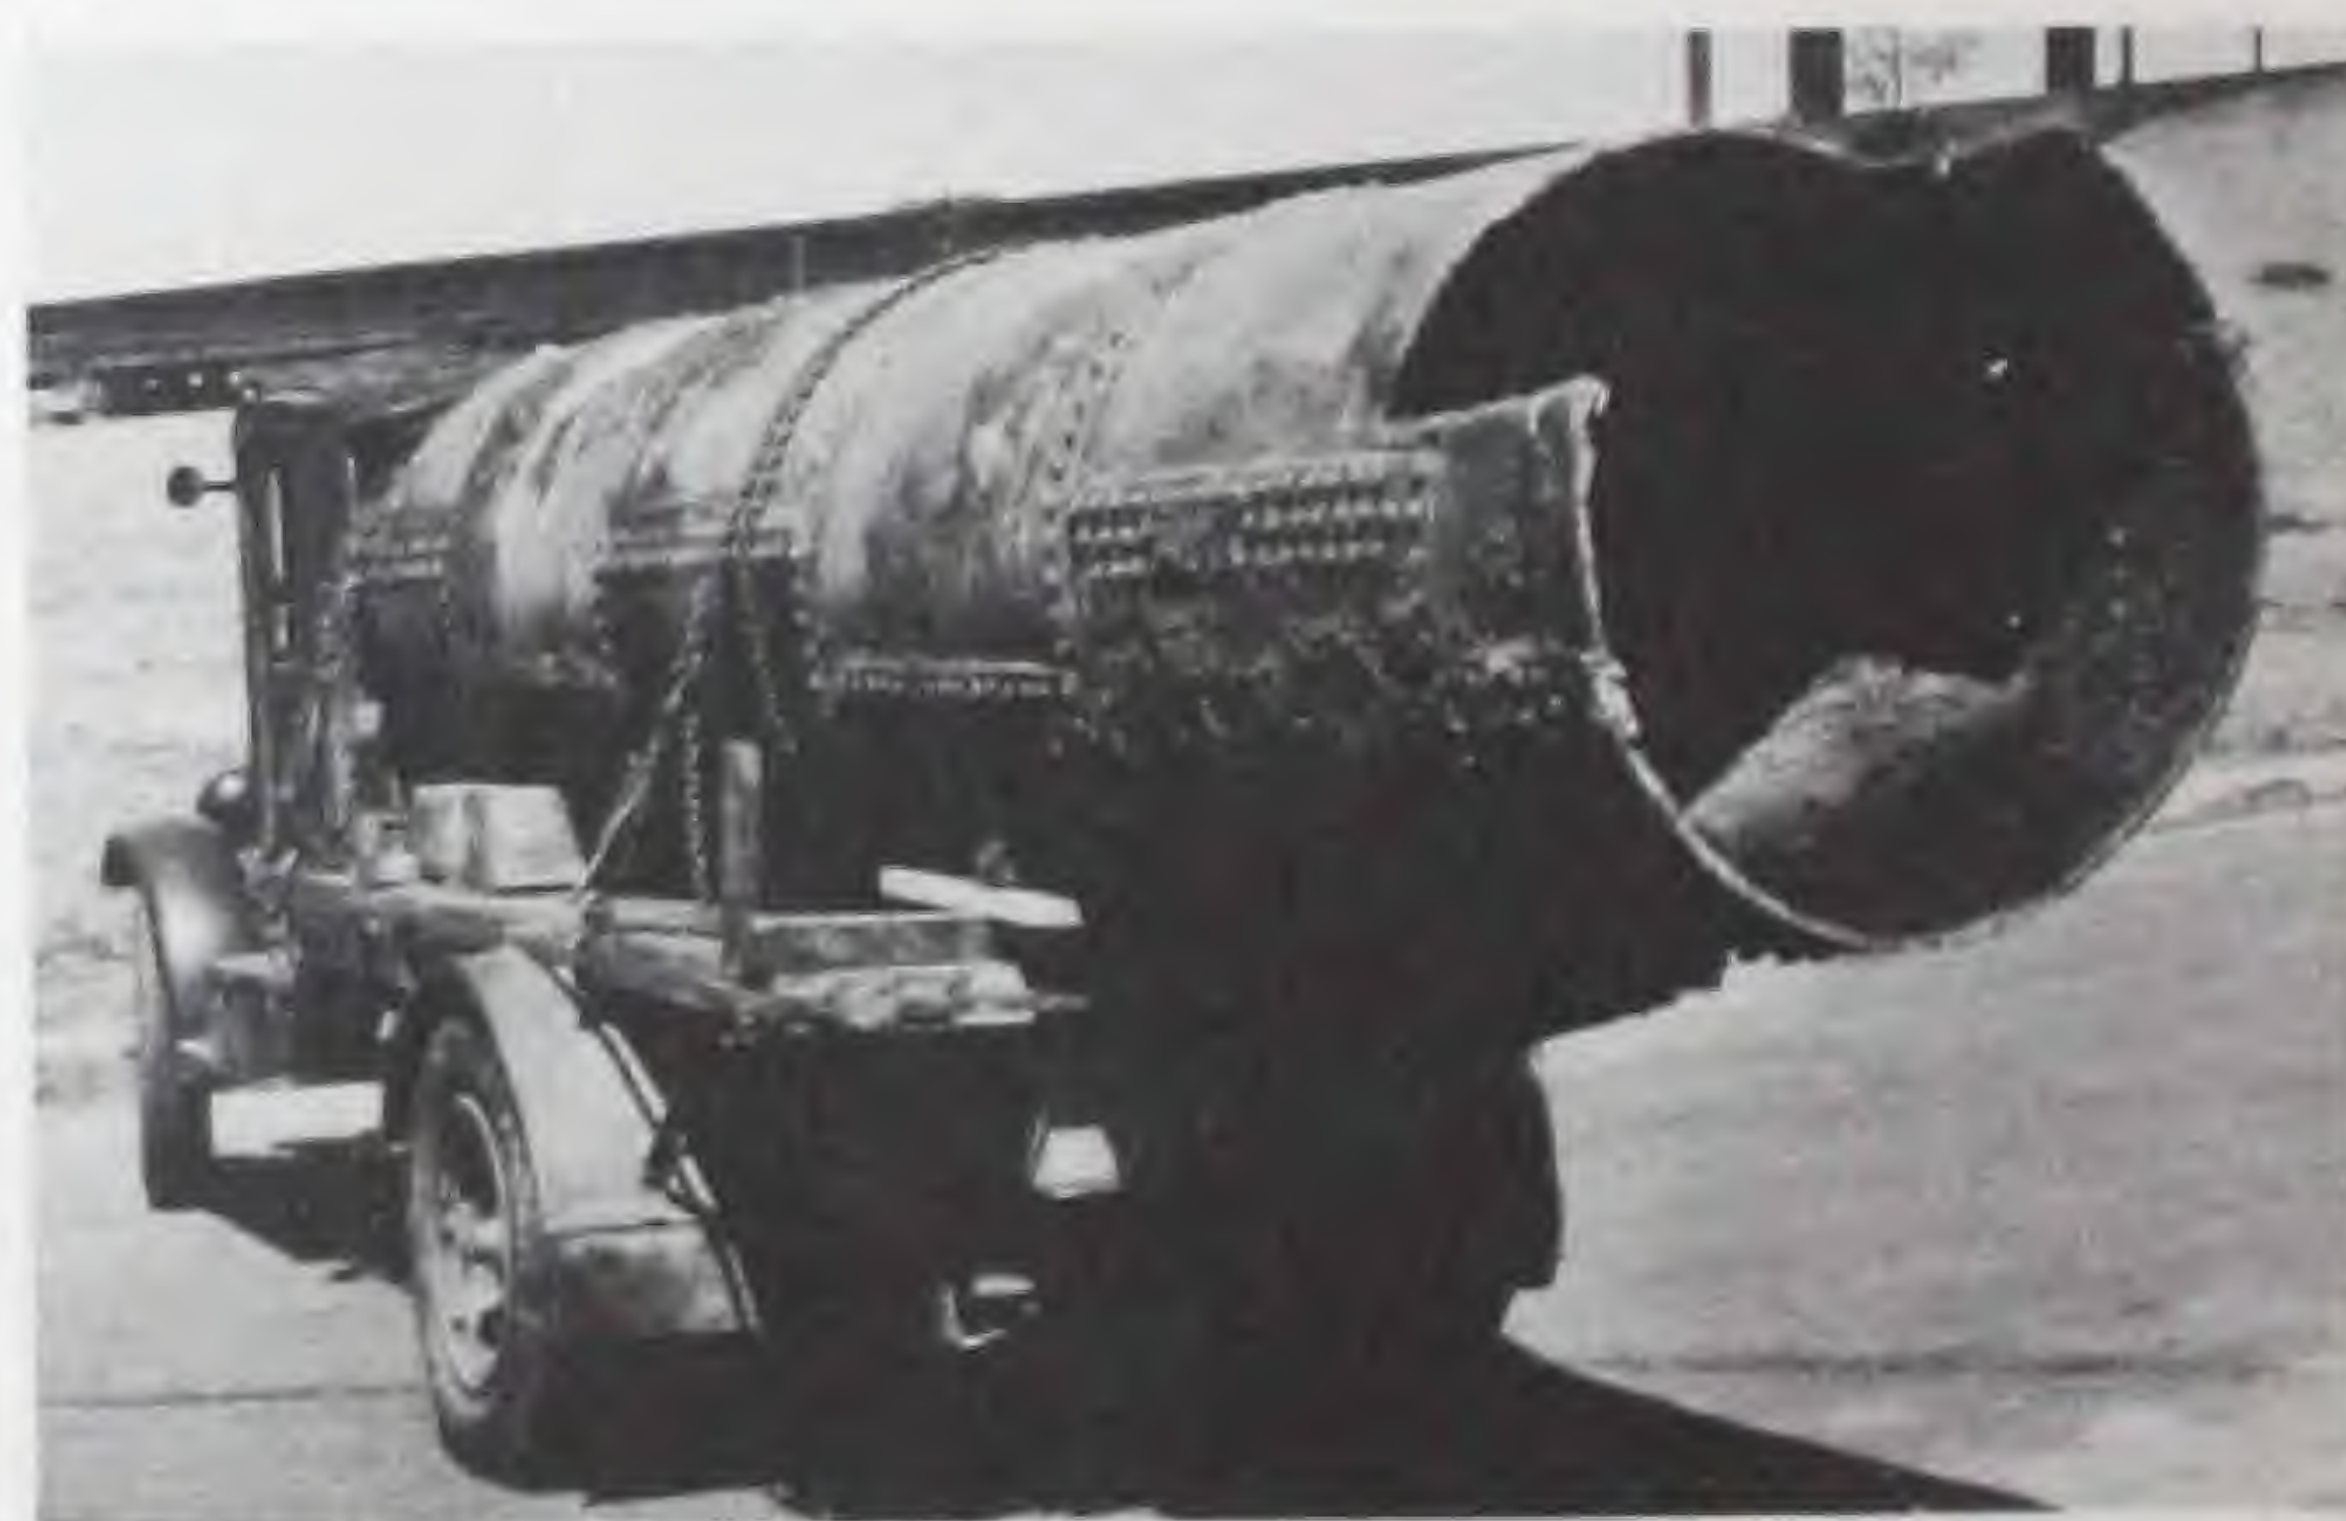
Fig. 1

When the Brilliant Pumping Station was connected to this line, it was necessary to remove the section of pipe shown in Figure 1. Analysis of the metal revealed that it was genuine wrought iron of normal quality and the surface of the pipe was in excellent condition.

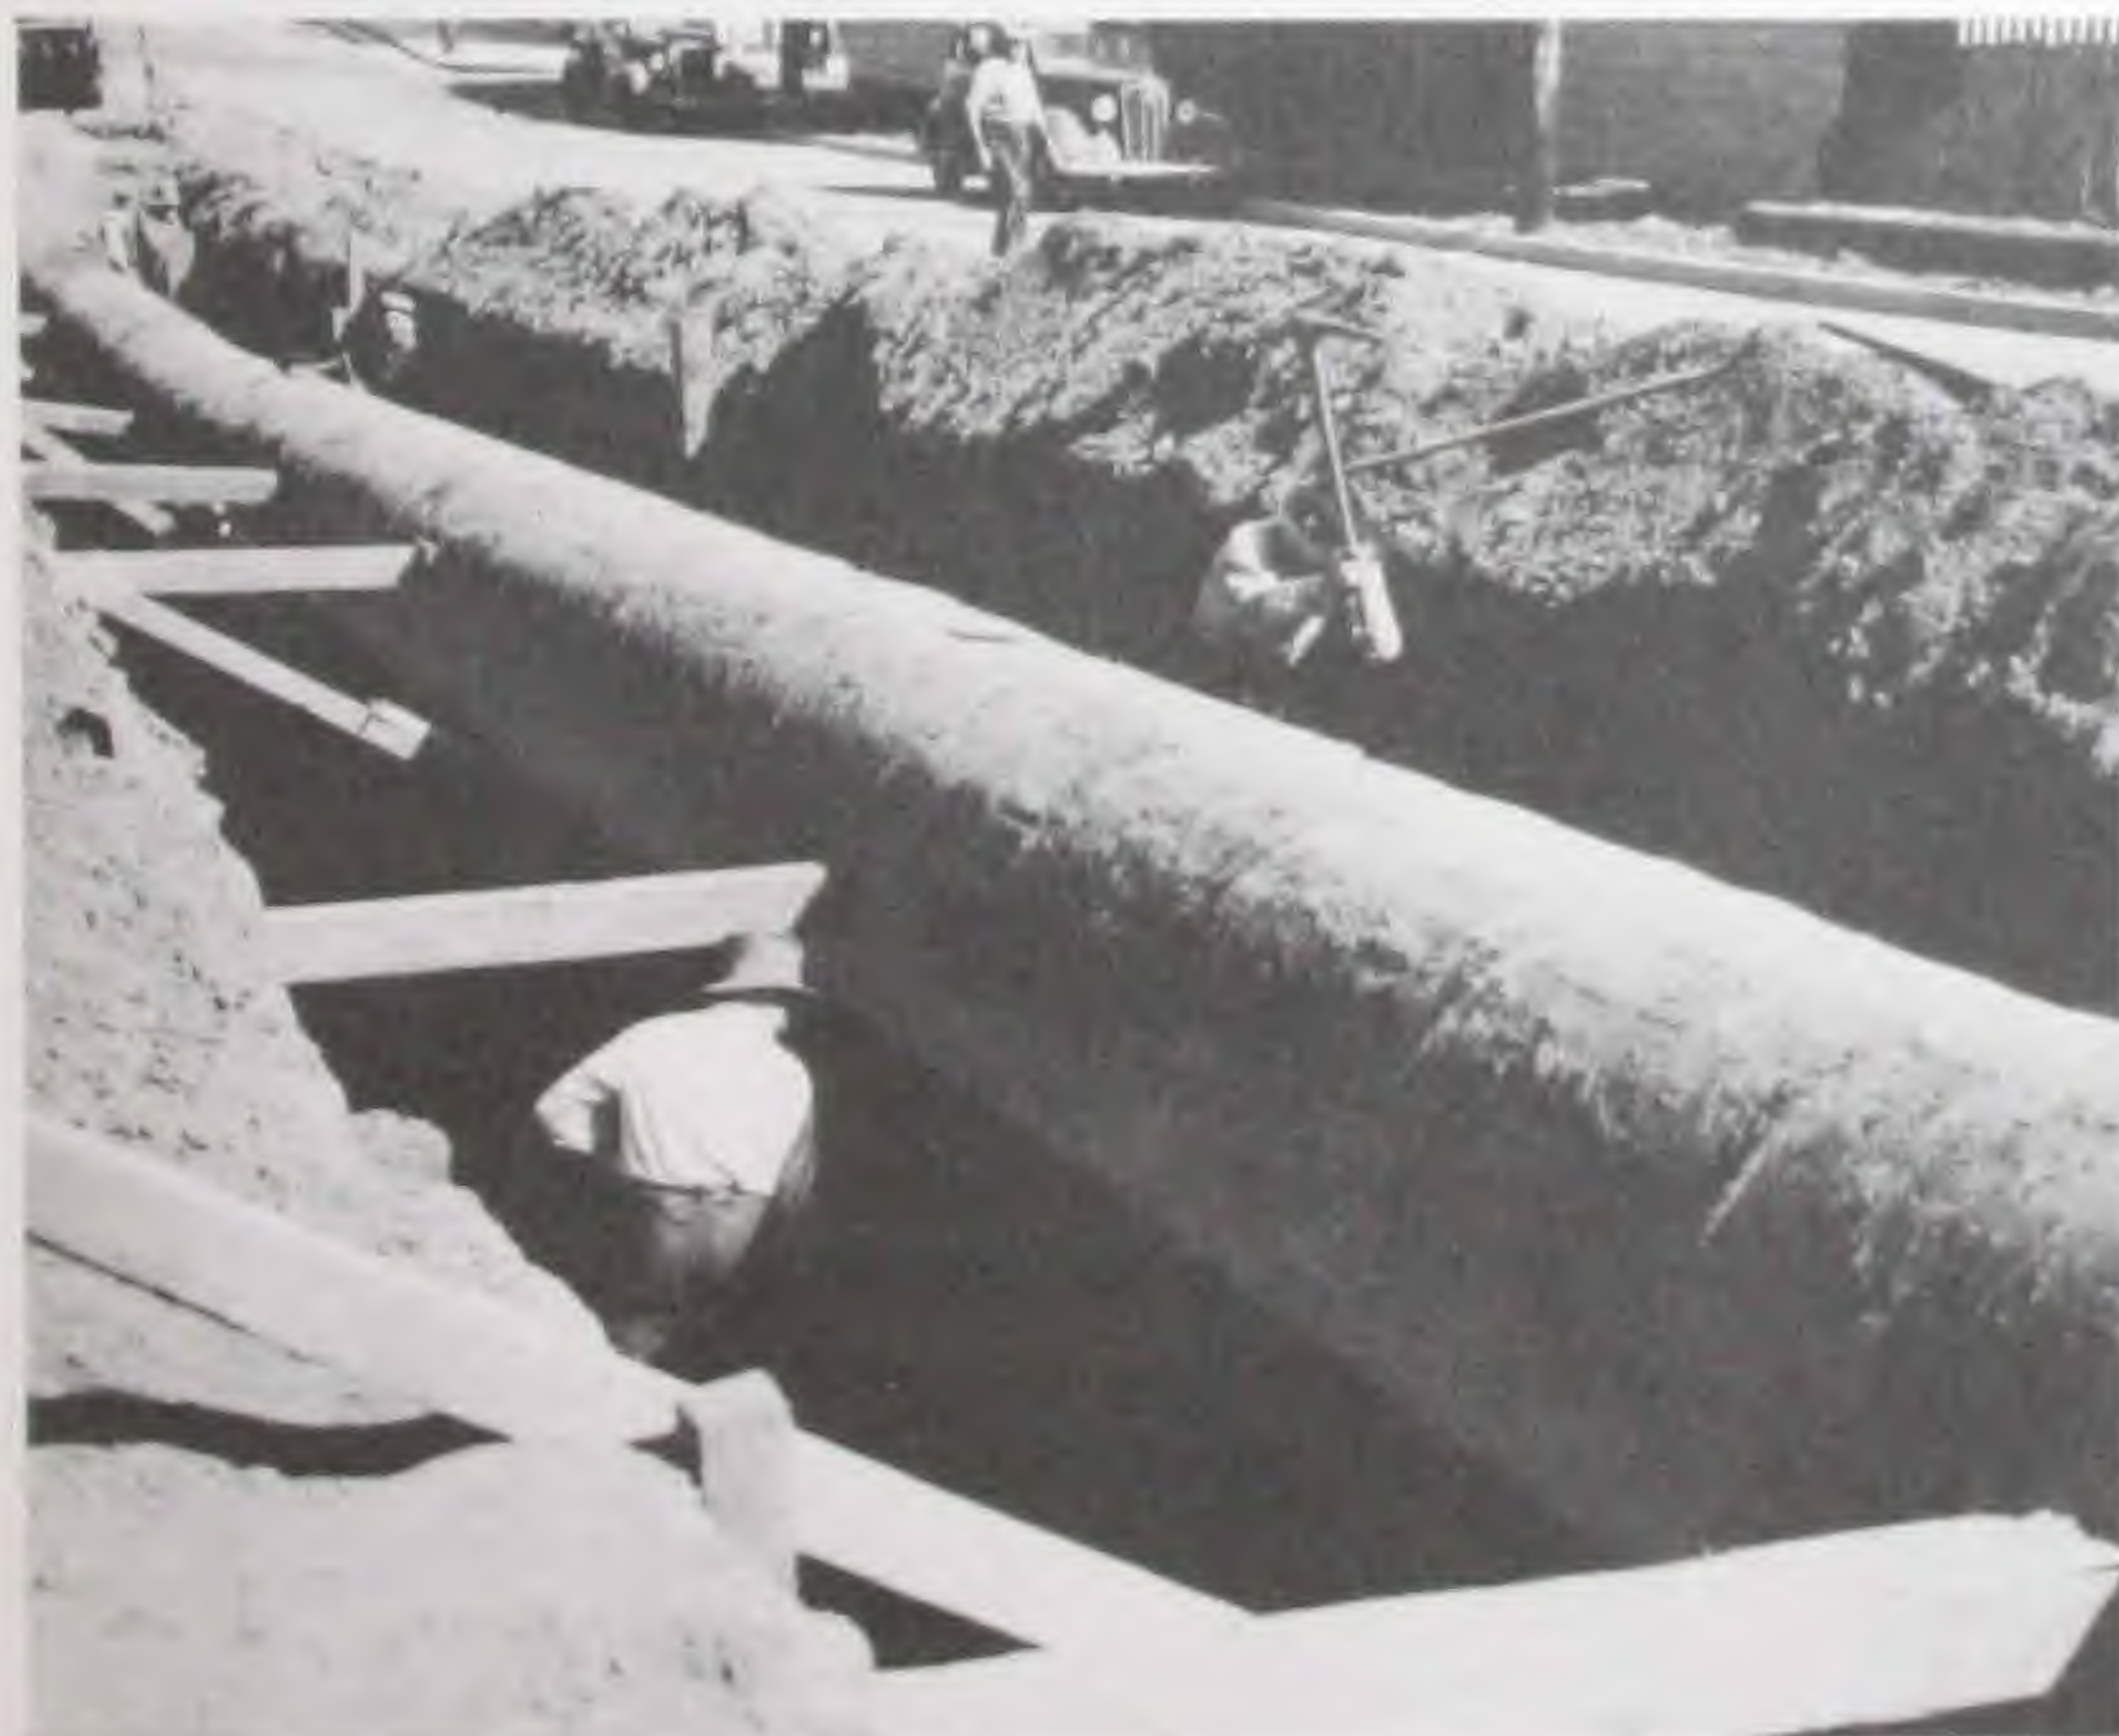
Fig. 2

For example, in Figure 2 workmen are shown removing a 200 ft. section of 44" O.D.  $\frac{1}{4}$ " wall genuine wrought iron pipe. It had been in continuous service for 54 years and no holes or thin spots could be found in it. Accordingly it was cleaned and placed in stock for making replacements or extensions.

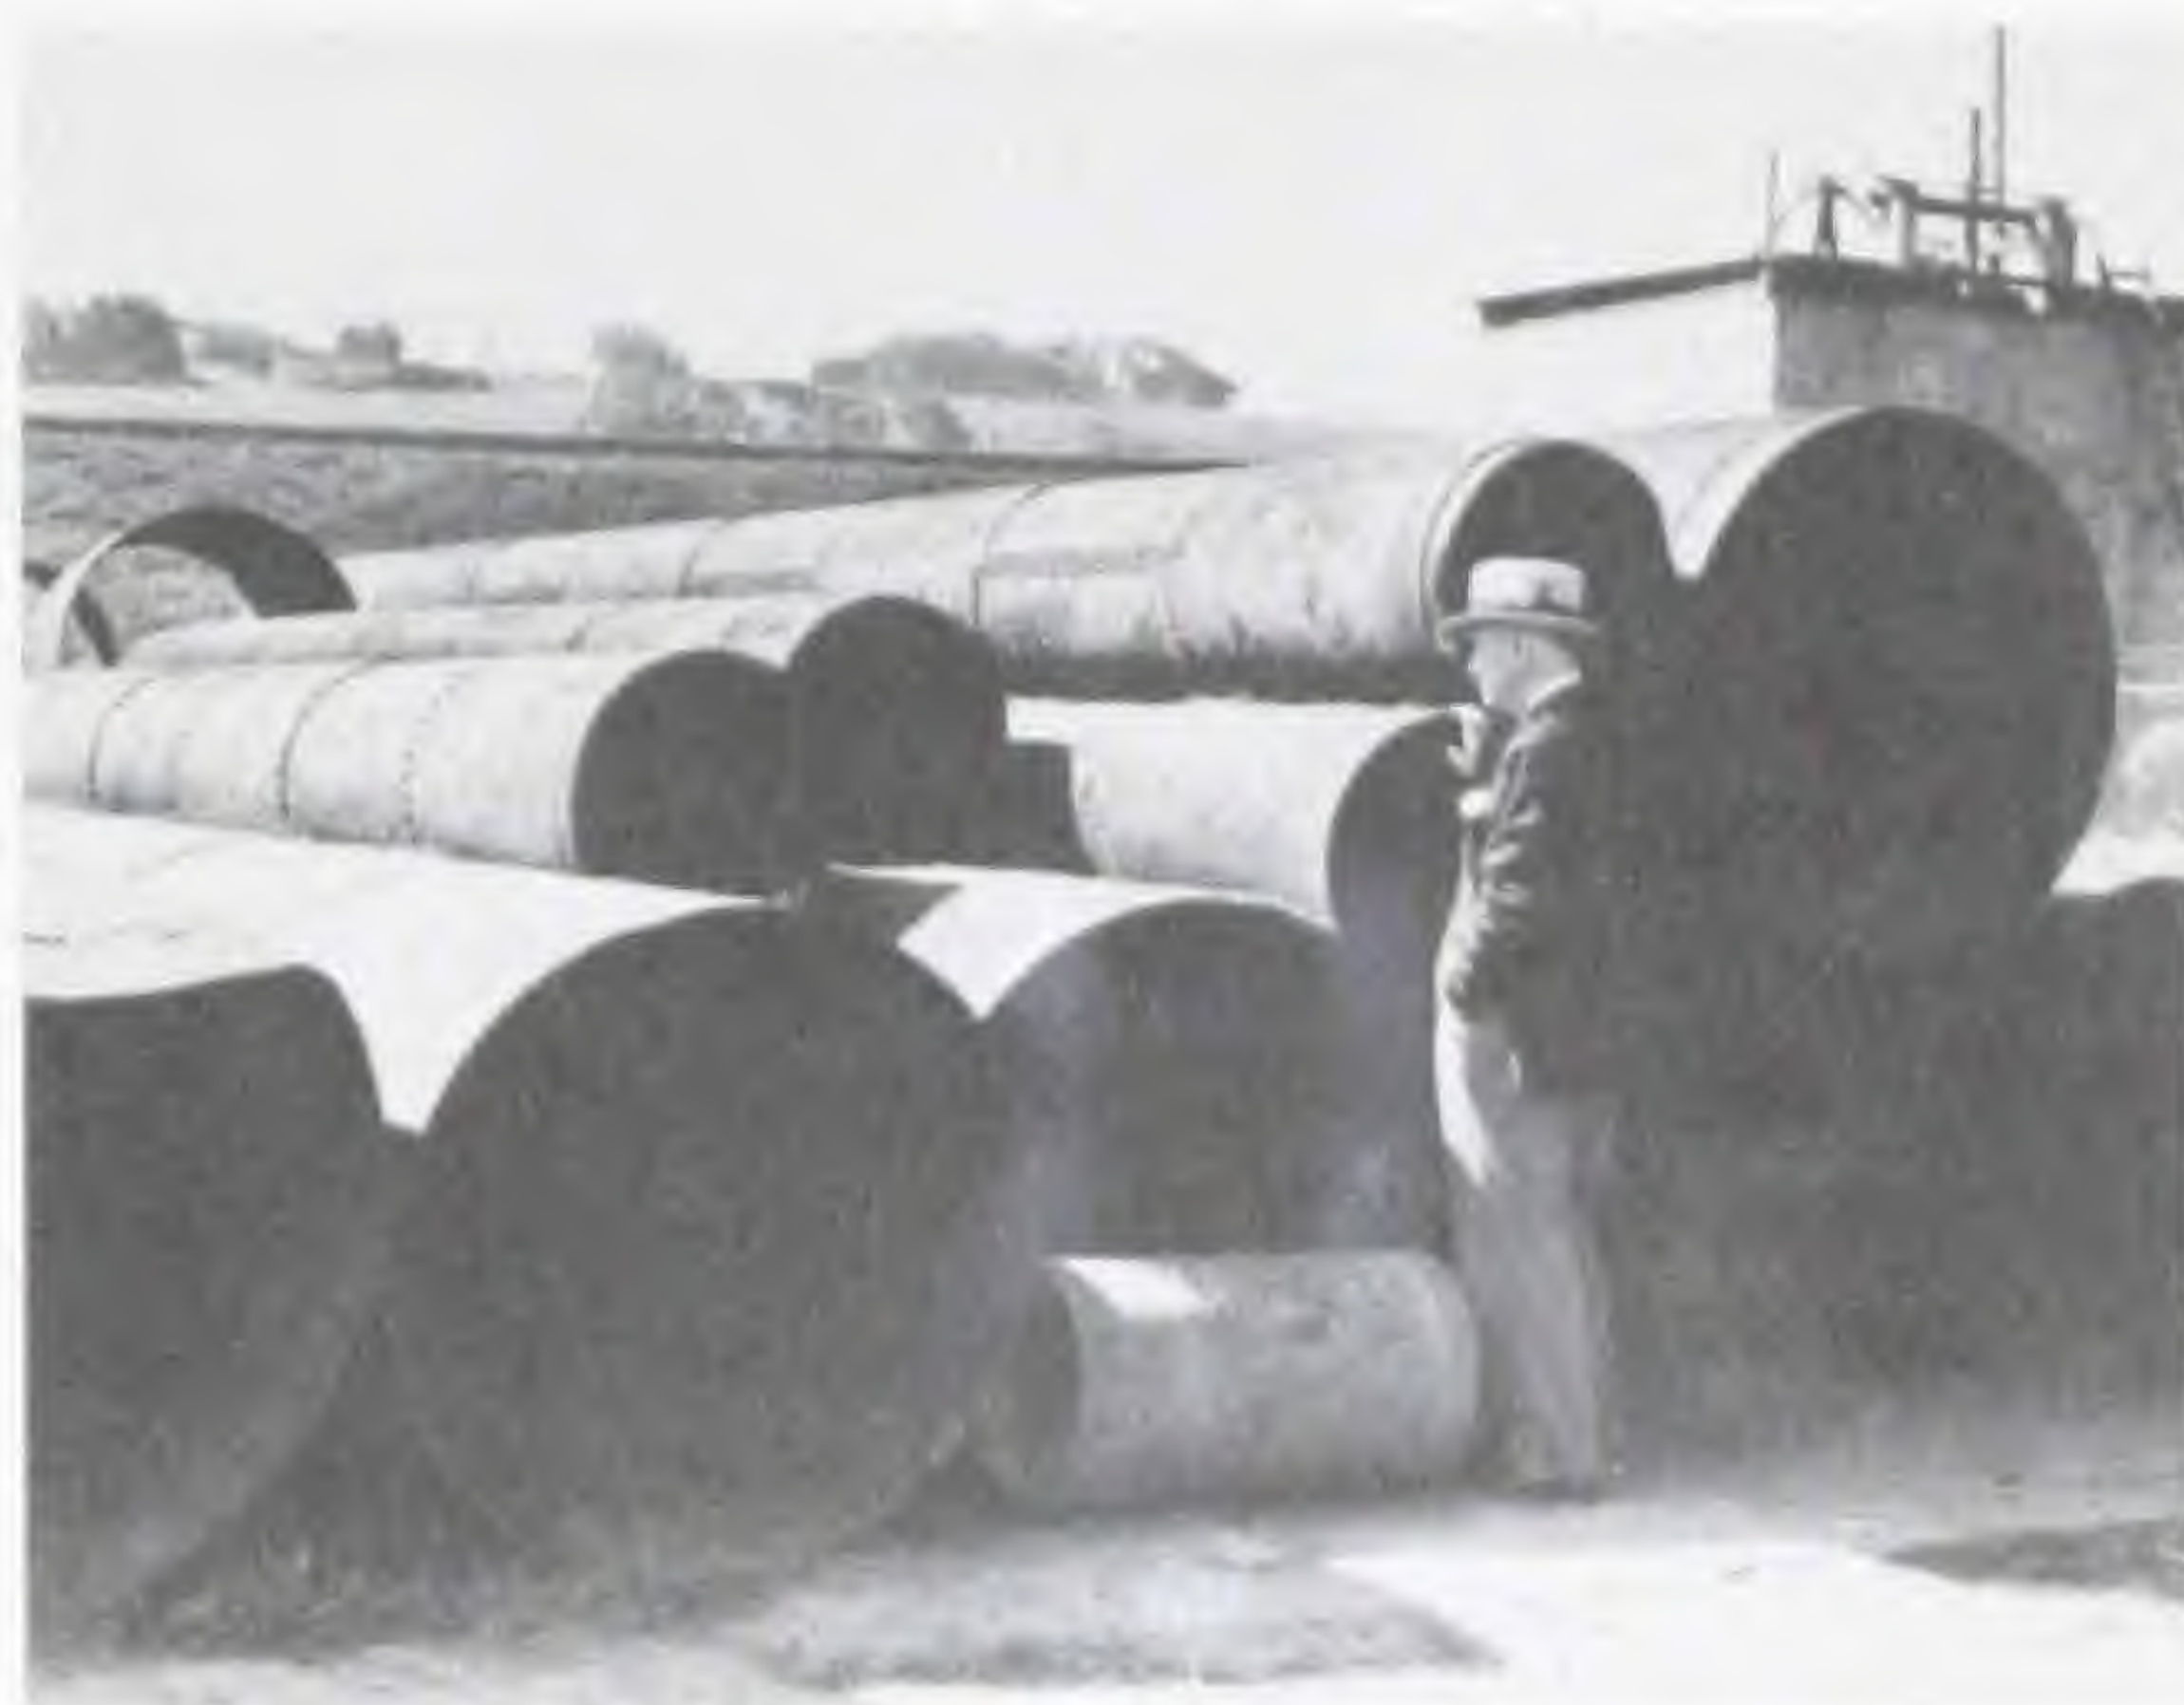
Fig. 3

The pipe used to replace the 54 year old material was also wrought iron that had served between 30 and 40 years before removal for cleaning. Part of it is shown in Figure 3.

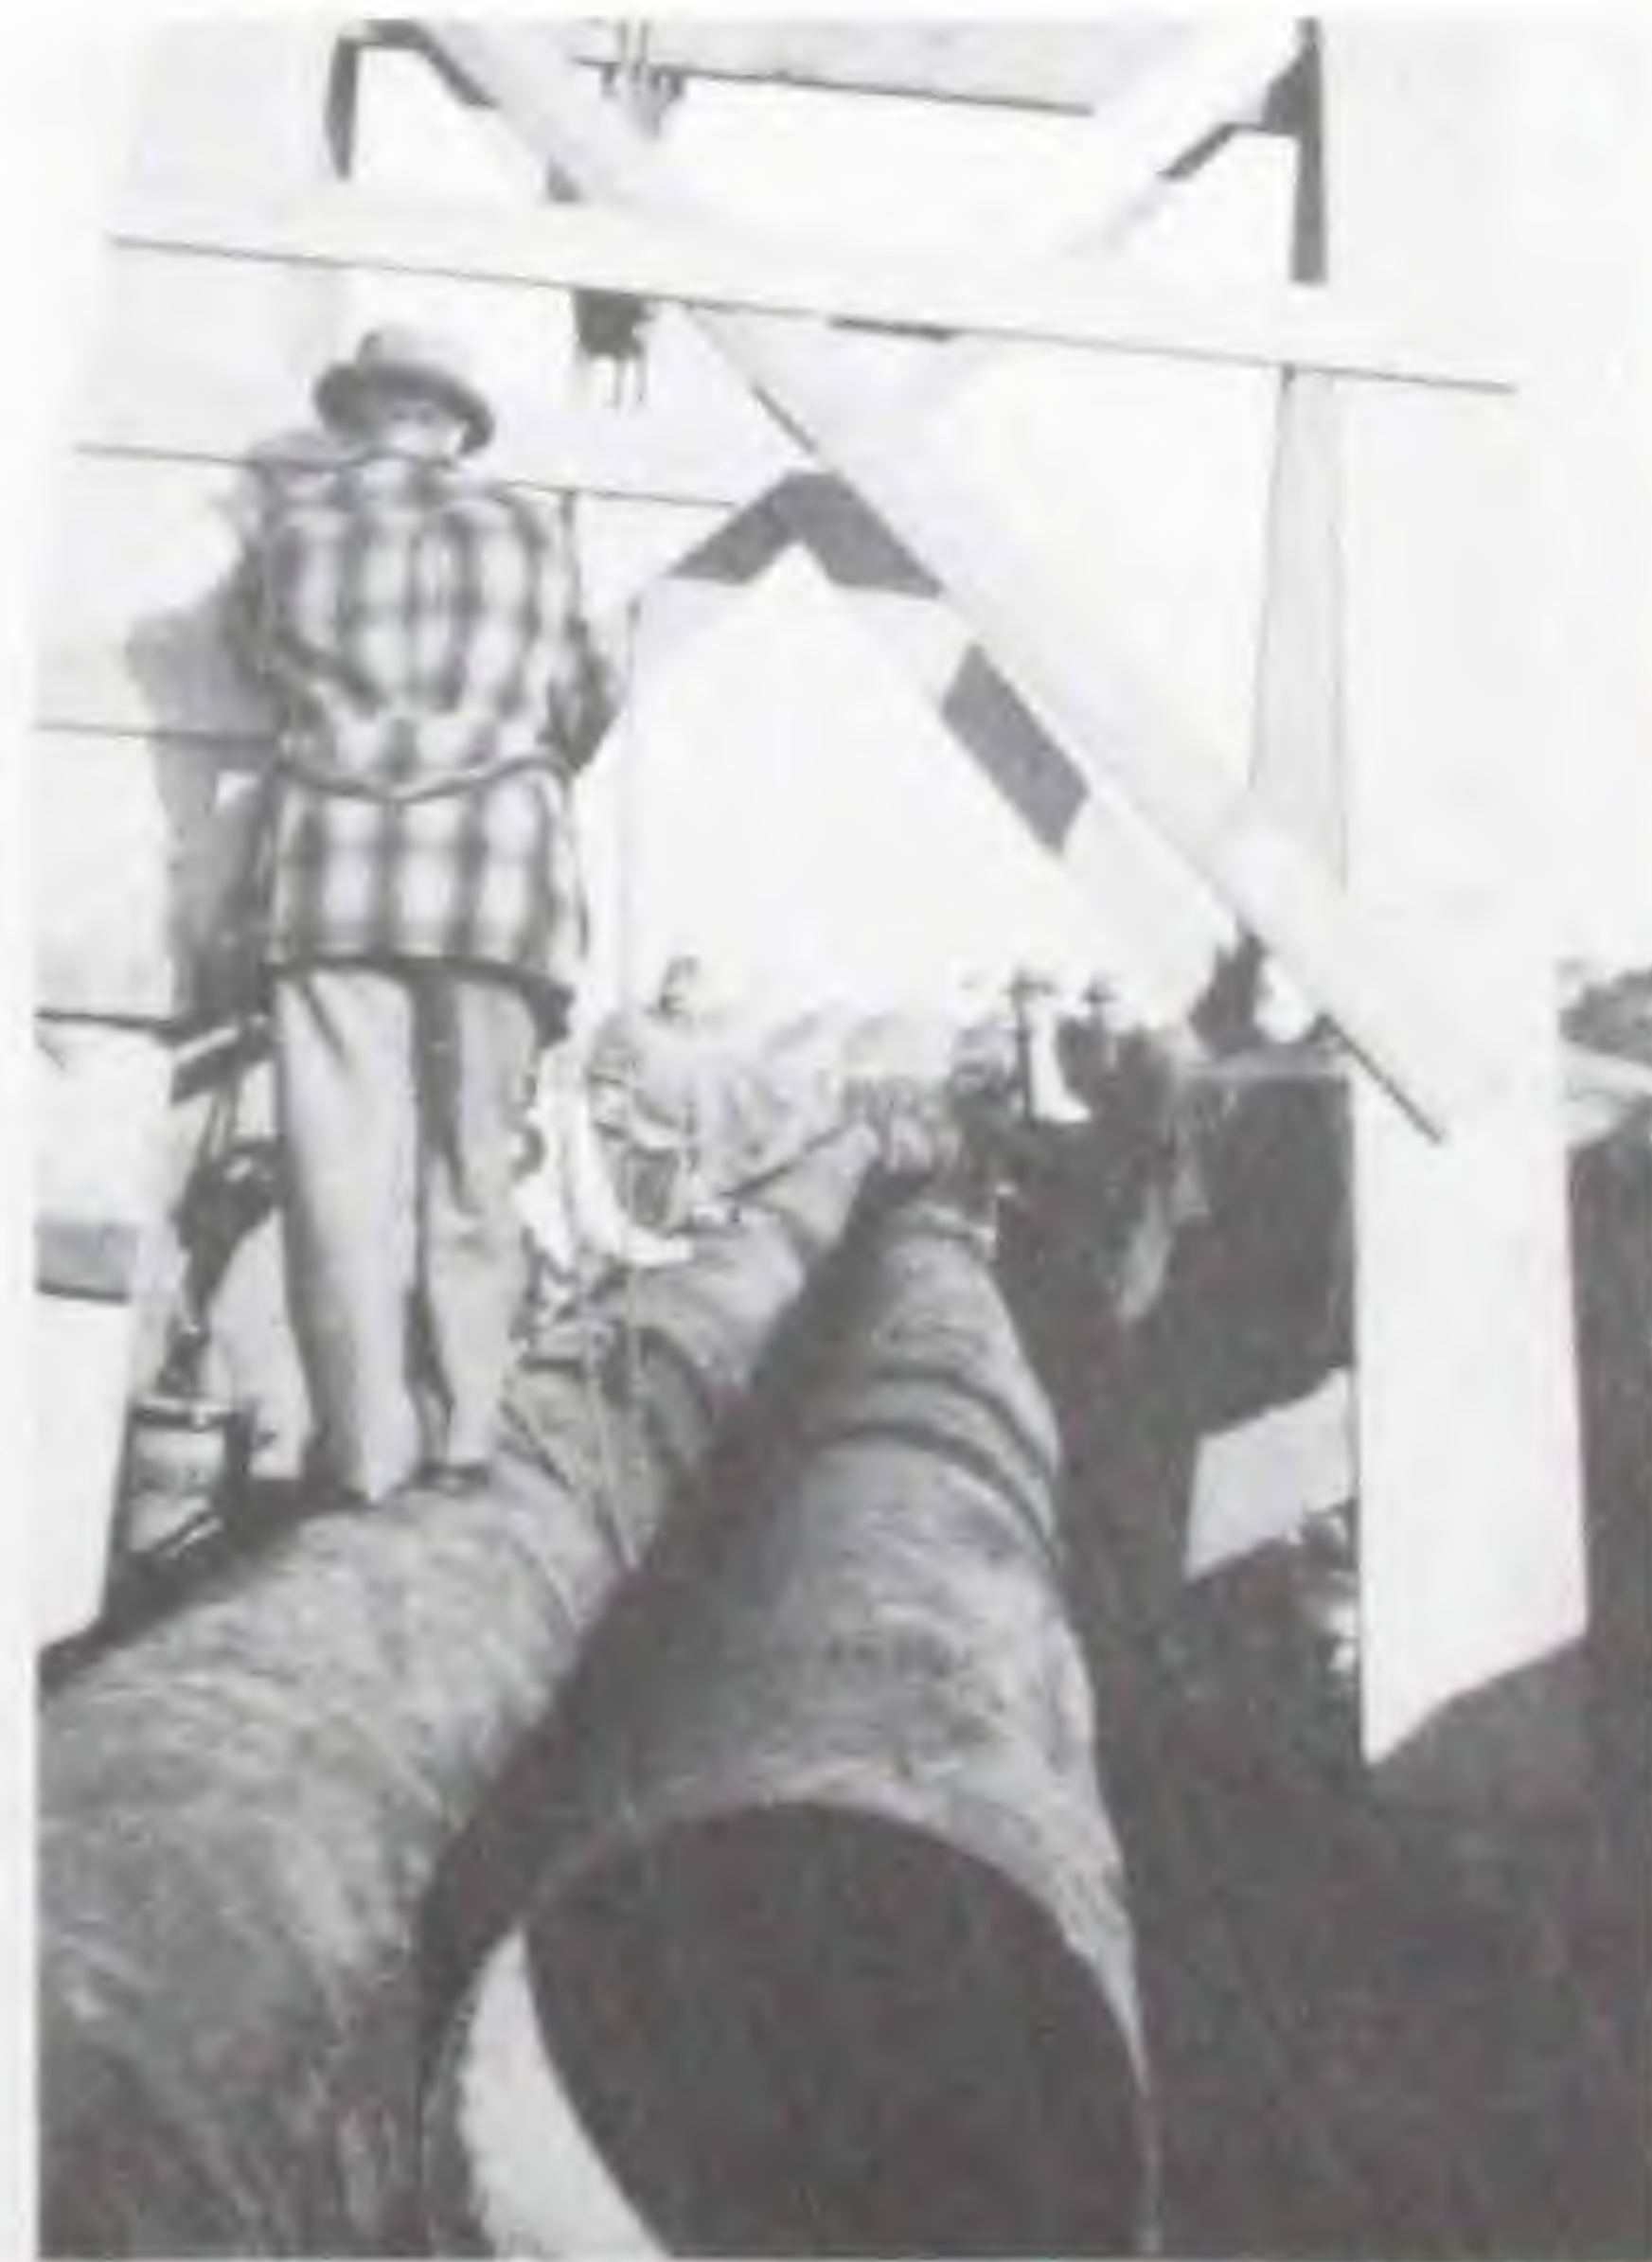
Fig. 4

Another old line was recently moved to make way for the Metropolitan Life Insurance Company Building Program on the Inglewood Golf Course in West San Francisco. About 1340 ft. of 22" pipe with  $\frac{1}{8}$ " wall thickness, and 5430 ft. of 23"— $\frac{3}{16}$ " wall wrought iron pipe were removed. Figure 4 shows the work in progress.

During the 1906 earthquake, San Francisco's only water supply was obtained through this pipe, from Lake Merced. When removed, every foot of the old pipe was examined and found to be in excellent condition.

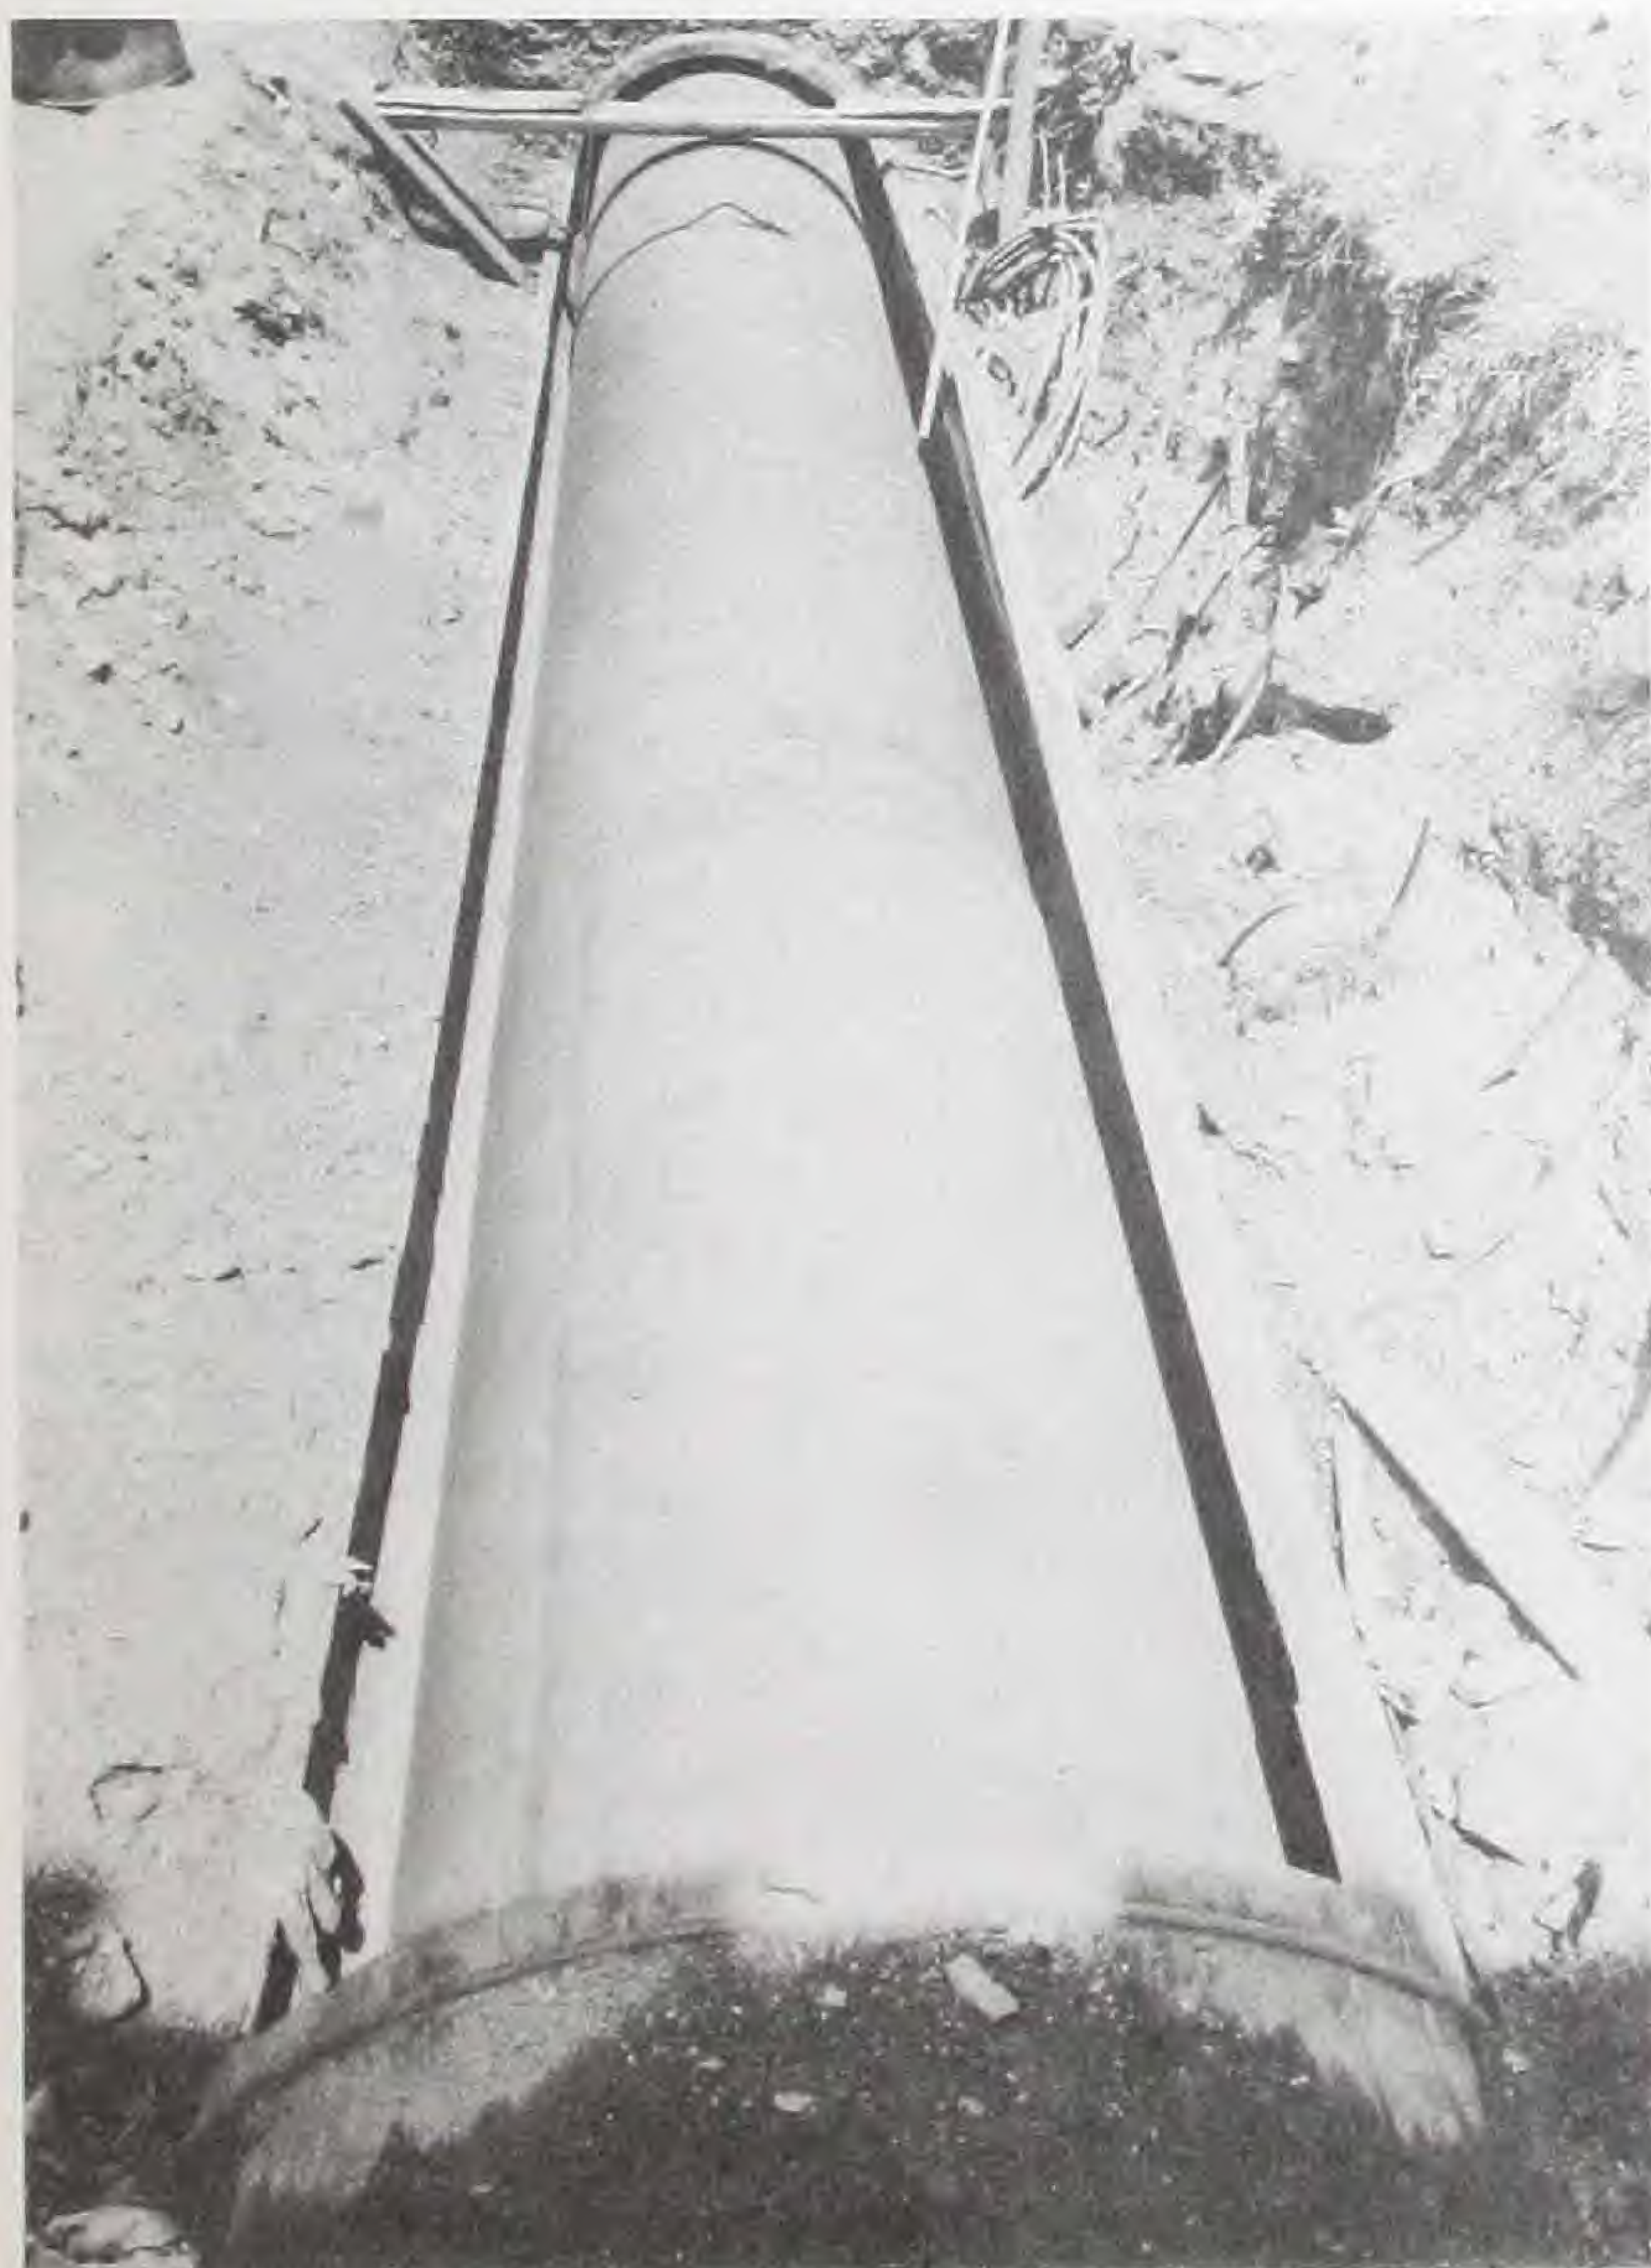
Fig. 8

Figure 8 shows a new wrought iron penstock over 200 feet long and 52" in diameter being installed at the American Felt Company's plant in Glenville, Connecticut. Five-sixteenth inch plates were used by Walsh Holyoke Steam Boiler Company of Holyoke, Massachusetts, in fabricating this pipe and, as can be seen in the photograph, the pipe is laid inside the old wooden penstock which was being replaced. Due to seepage of ground moisture through the old penstock, and the possibility of tannic acid being leached from the wood, highly corrosive conditions can be expected and for this reason, wrought iron was selected.

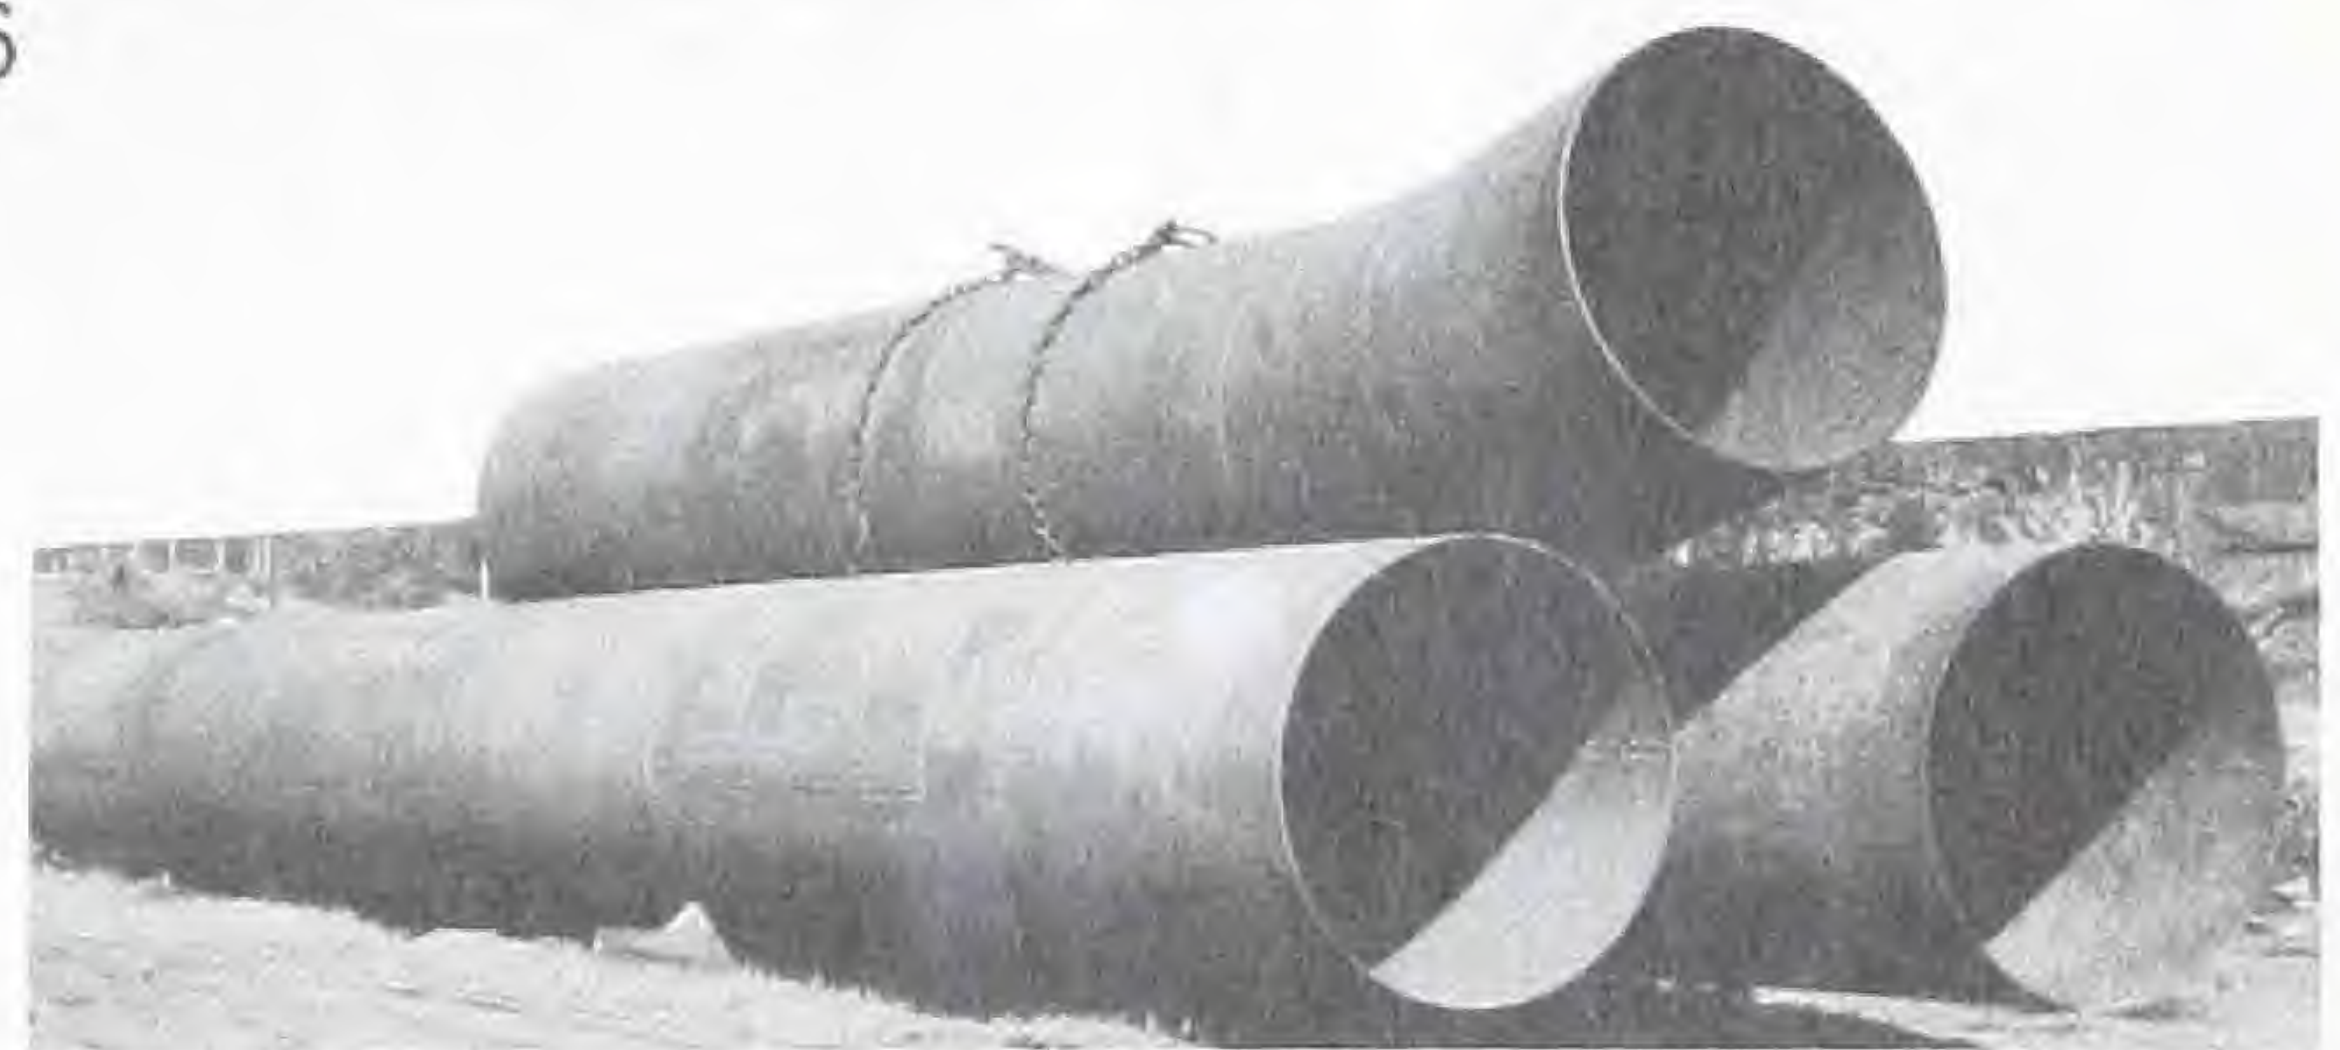
Fig. 7

Condenser cooling water for the Central Maine Power Company's plant flows through the penstock shown, during the process of installation, in Figure 6. This pipe is of welded construction and was fabricated from  $\frac{3}{8}$ " Byers wrought iron plates. The penstock is 239' long. Several sections, ready for installation, are shown in Figure 7.
